**Subject: Annual Inspection Report  
Abbeville Municipal Airport**

## ANNUAL INSPECTION REPORT

ABBEVILLE MUNICIPAL AIRPORT

ABBEVILLE, ALABAMA

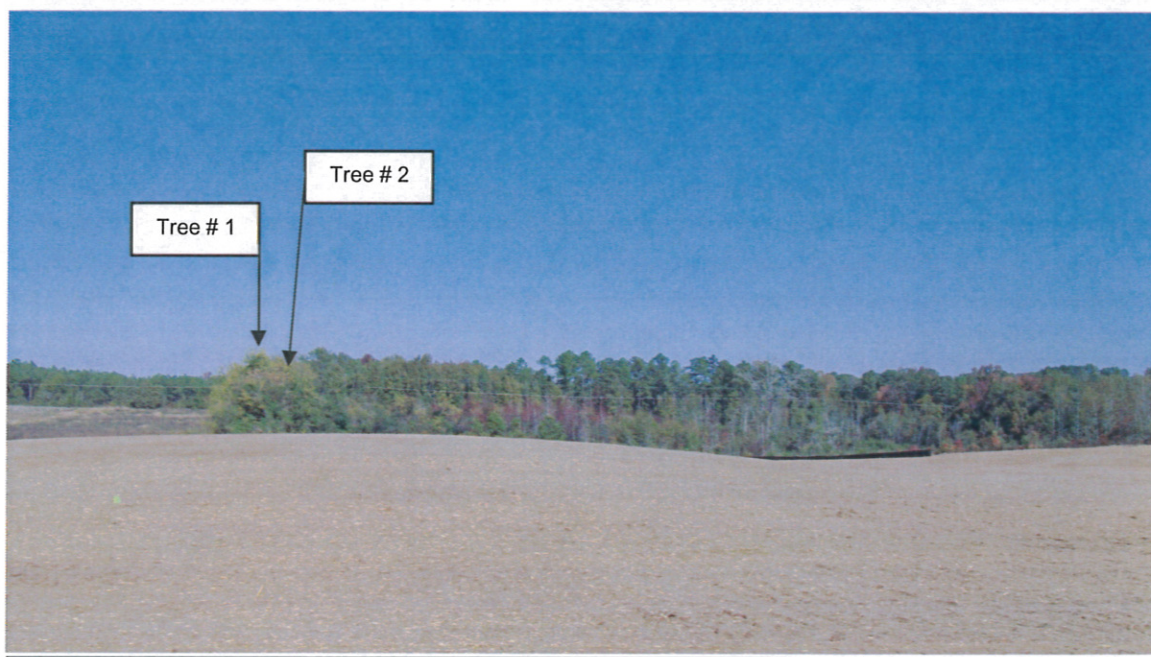
**Photo # 1 – Runway 17 Approach**

- Runway 17 – Trees identified as Tree # 1 and Tree # 2 violate the ALDOT 20:1 approach/departure path (See Photo # 1 and Appendix 2).
- Runway 35 – No obstructions (See Photo # 2).

- The current clearing project should remove all obstructions to the 20:1 slope within the approach/departure path for runway 17.

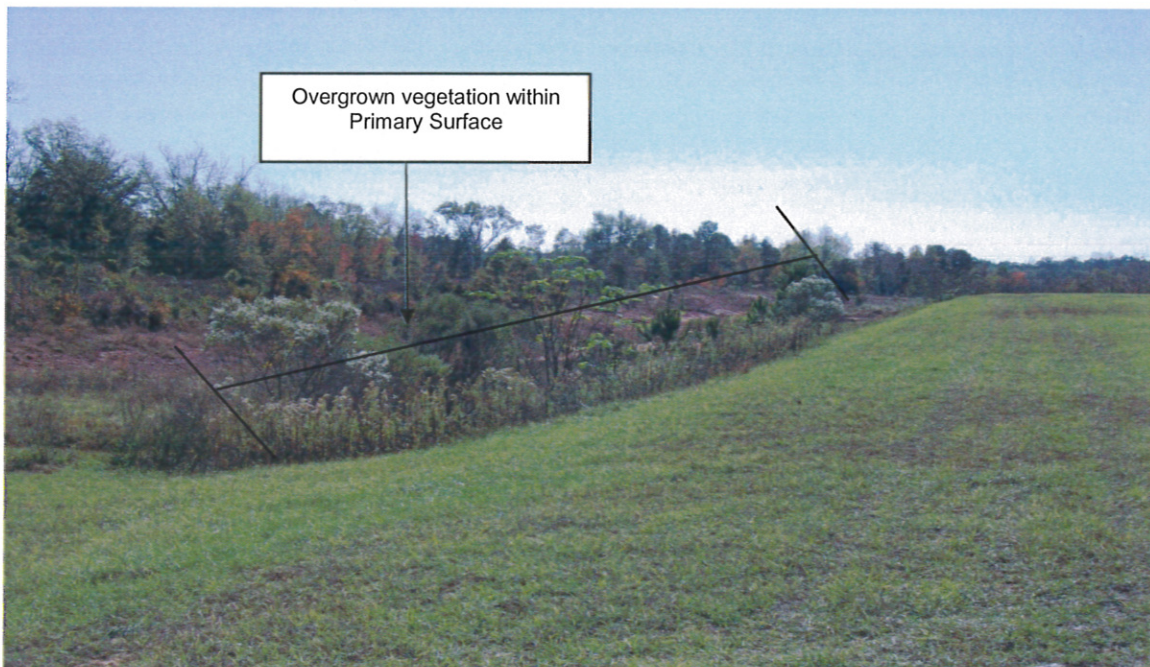
**Photo # 3 – Primary Surface Obstructions**

- The primary surface is violated by brush and small trees on both sides of the approach end of runway 35 (See Photo # 3 and Photo # 4).

- Remove all obstructions with the primary surface and maintain in a manner that will preclude vegetation overgrowth within the primary surface.

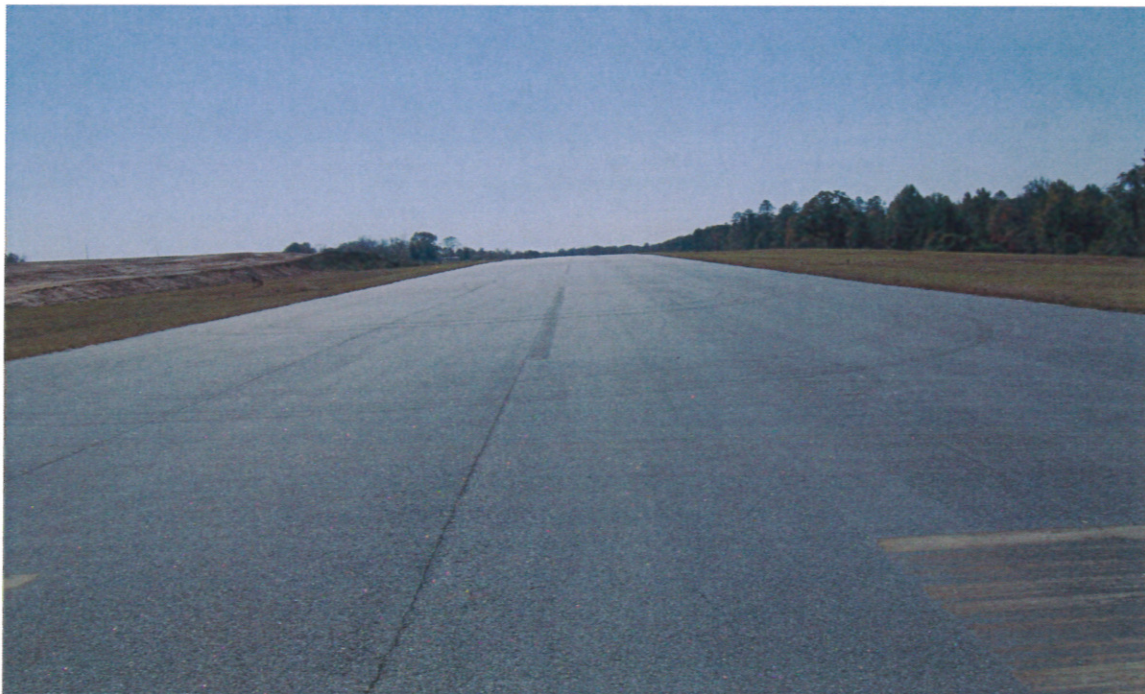
**Photo # 5 – Markings**

- Runway numbers and centerline markings are faded (See Photo # 5).

- Markings should be replaced in accordance with FAA AC 150/5340-1J.

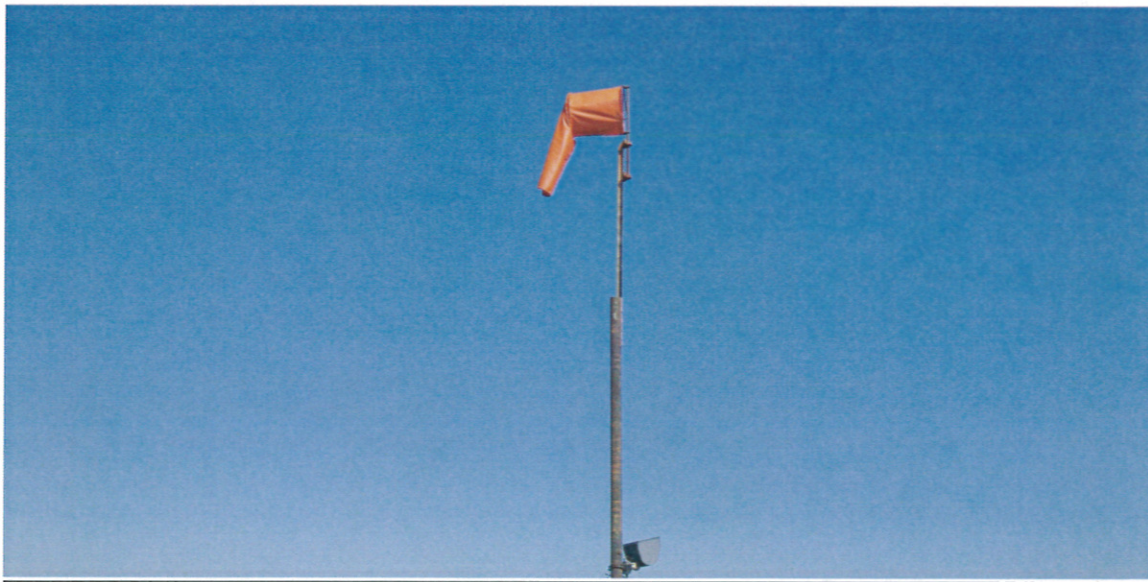
**Photo # 6 – Wind Cone**

- The wind direction indicator (wind cone) was operational (See Photo # 6).

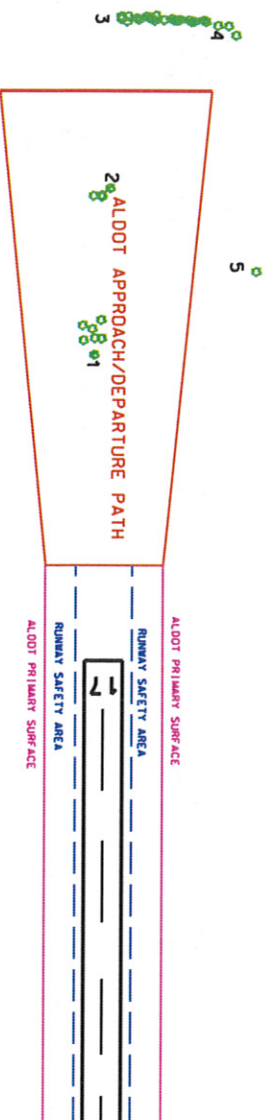
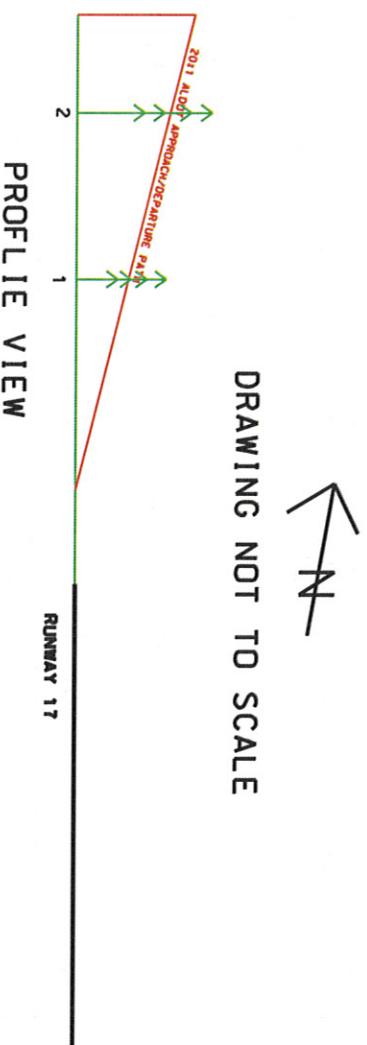
## REQUIREMENTS FOR STATE AIRPORT LICENSE RUNWAY 17

1. TREES - 38' ABOVE RUNWAY END  
642' FROM RUNWAY END  
20' RIGHT OF CENTERLINE  
11:1 OBSTRUCTION CLEARANCE SLOPE
2. TREES - 57.4' ABOVE RUNWAY END  
993' FROM RUNWAY END  
13' LEFT OF CENTERLINE  
13:1 OBSTRUCTION CLEARANCE SLOPE
